## How to check the calibration for perfection of the VNWA or any other VNA

### Preface:

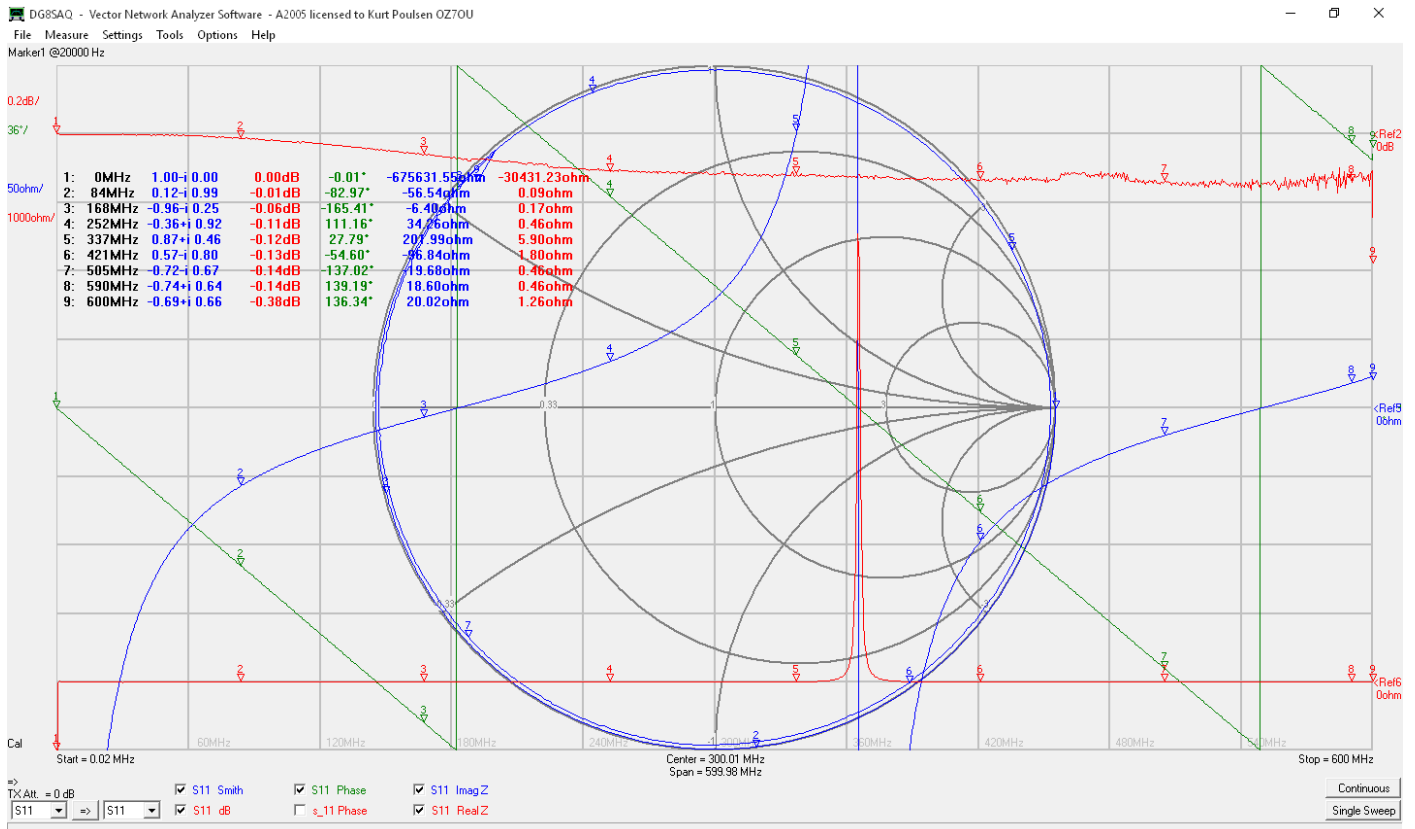
## Below seen the three APC 7 airlines in open condition

To see how accurate such a test can be, see below for a clean APC7 system test

Finally the VNWA calibrated using a APC7 calibration kit using my APC Front end to the VNWA. Then the APC7 to SMA adaptor not in use.
